LEGIONELLA RISK ASSESSMENT

DOMESTIC WATER SYSTEMS

CUSTOMER: ROSEHILL HOUSING ASSOCIATION

SITE: 2 ELLISTON DRIVE

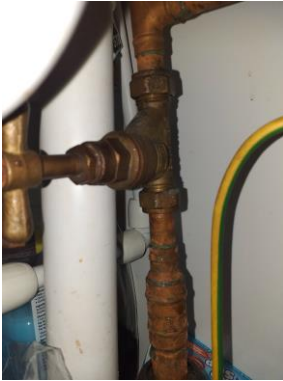
Incoming Main

<i>Location</i>	Under Kitchen Sink	<i>Recommendations / Comments</i>
System ID No.	1	
Type	Town Mains	
Supply company	Scottish Water	
Labelled	No	
Insulation	No	
Material	MDPE	
Drain / injection point	No	
Temperature	11.2°C	
Isolation valve	Yes	
Accessibility	Good	
Additional comments	-	
Level of Risk	LOW

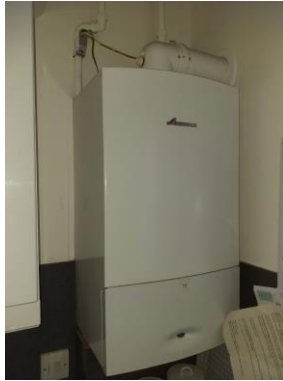
Combination Boiler

Location	Kitchen			Recommendations
System ID No.	2			<p>CATEGORY: 3</p> <p>Lag pipework to reduce any possible thermal gain or loss.</p> <p>HSG 274 Part 2: Para 2.36 & 2.37</p>
How is the water heated?	Gas			
Is supply pipe fitted with check valve?	Yes			
Materials / Manufacturer	Copper / Worcester			
Is the heater working and in regular use?	Yes			
Temperatures	Cold supply	Hot outlet	Gauge	
	11°C	61°C	-	
Dead ends on Pipework	No			
Non WRC Materials	No			
Is the pipework insulated?	No			
Is there an expansion vessel fitted?	Yes			
Is the quick fill loop still connected?	No			
Condition / Comments	-			
Level of Risk	LOW

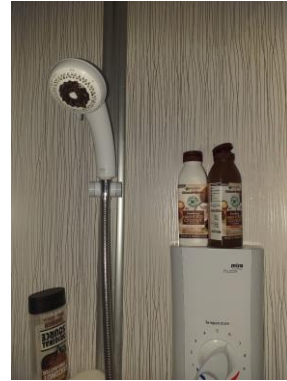
Electric Shower

Mains supplied electrical showers present a significantly lower risk of bacterial population and dispersion due to the water source for this type of outlet. Although an aerosol is produced, the temperature of the water source would render any legionella bacteria dormant.

Location		Kitchen	Bathroom	Toilet	Recommendations
System ID No(s)		1 and 2	1 and 2	1 and 2	<p>CATEGORY: 2</p> <p>Clean + disinfect showerheads and hoses quarterly HSG 274 Part 2: Table 2.1</p> <p>Remove dead leg pipework. HSG 274 Part 2: Para 2.77</p>
Dead Ends		Yes	None Visible	None Visible	
Spray Potential		Low	High	Low	
Cold temp after 2 min (°C)		11.4	11.6	11.6	
Hot temp after 1 min (°C)		61.4	60.8	61.3	
No of TMV's in location		-	-	-	
TMV	Cold In (°C)	-	-	-	
	Hot In (°C)	-	-	-	
	Mixed Out (°C)	-	-	-	
Frequency of Use		Daily	Daily	Daily	
Additional Comments		Dead ender under sink	-	-	
Outlets in Location		Sink, Washing machine.	WC Cistern, Wash hand basin, Electric shower.	WC Cistern, Wash hand basin.	
Additional Localised Risk		MEDIUM	MEDIUM	LOW

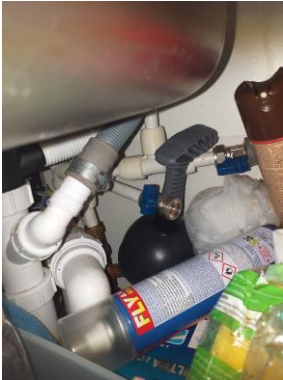
Dead Leg in kitchen

- Showerheads and hoses should be cleaned, descaled and disinfected quarterly
- There is a small dead leg under the kitchen sink; this should be removed back to the nearest branch point.
- Insulation should be fitted to all hot and cold water pipework to reduce thermal loss or gain.
