LEGIONELLA RISK ASSESSMENT

DOMESTIC WATER SYSTEMS

CUSTOMER: ROSEHILL HOUSING ASSOCIATION

SITE: 3 HARTSTONE TERRACE - Glasgow

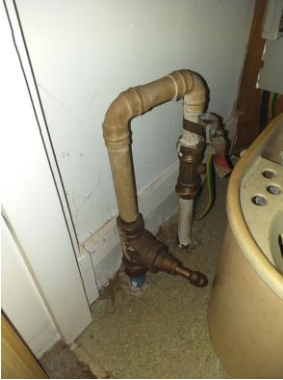
Incoming Main

<i>Location</i>	Hall Cupboard	<i>Recommendations / Comments</i>
System ID No.	1	
Type	Town Mains	
Supply company	Scottish Water	
Labelled	No	
Insulation	No	
Material	MDPE	
Drain / injection point	No	
Temperature	11.6°C	
Isolation valve	Yes / No	
Accessibility	Good	
Additional comments	-	
Level of Risk	LOW

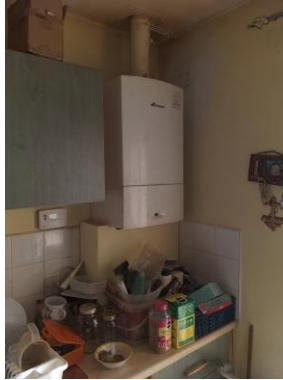
Combination Boiler

Location	Kitchen			Recommendations
System ID No.	2			<p>CATEGORY: 3</p> <p>Lag pipework to reduce any possible thermal gain or loss.</p> <p>HSG 274 Part 2: Para 2.36 & 2.37</p>
How is the water heated?	Gas			
Is supply pipe fitted with check valve?	Yes			
Materials / Manufacturer	Copper / Worcester			
Is the heater working and in regular use?	Yes			
Temperatures	Cold supply	Hot outlet	Gauge	
	11.6°C	60,4°C	Not fitted	
Dead ends on Pipework	No			
Non WRC Materials	No			
Is the pipework insulated?	No			
Is there an expansion vessel fitted?	Yes			
Is the quick fill loop still connected?	No			
Condition / Comments	-			
Level of Risk	LOW

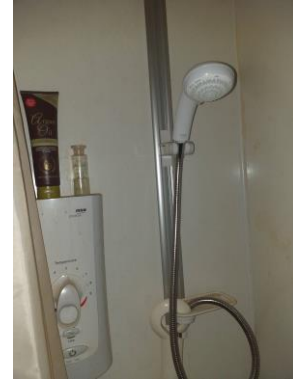
Electric Shower

Location		Kitchen	Bathroom	Recommendations
System ID No(s)		1 and 2	1 and 2	<p>CATEGORY: 2</p> <p>Clean + disinfect showerheads and hoses quarterly HSG 274 Part 2: Table 2.1</p>
Dead Ends		None Visible	None Visible / Yes	
Spray Potential		Low	Low	
Cold temp after 2 min (°C)		11.2	11.2	
Hot temp after 1 min (°C)		59.3	58.7	
No of TMV's in location		-	-	
TMV	Cold In (°C)	-	-	
	Hot In (°C)	-	-	
	Mixed Out (°C)	-	-	
Frequency of Use		Daily	Daily	
Additional Comments		-	-	
Outlets in Location		Sink, Washing machine.	WC Cistern, Wash hand basin, Electric shower.	
Additional Localised Risk		LOW	MEDIUM
