LEGIONELLA RISK ASSESSMENT

DOMESTIC WATER SYSTEMS

CUSTOMER: ROSEHILL HOUSING ASSOCIATION

SITE: FLAT 2/2 3 SEAMILL STREET

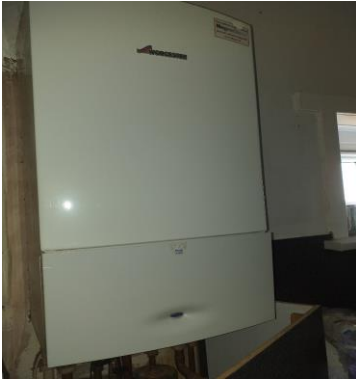
11.3°C	54.7°C	56.1°C	
Dead ends on Pipework	No			
Non WRC Materials	No			
Is the pipework insulated?	No			
Is there an expansion vessel fitted?	Yes			
Is the quick fill loop still connected?	Yes			
Condition / Comments	-			
Level of Risk	MEDIUM

Combination Boiler

Location	Utility Room			Recommendations
System ID No.	2			<p>CATEGORY: 2</p> <p>Remove quick fill link between mains supply and closed central heating systems. If systems contain anti-freeze or corrosion inhibitor such as Glycol a backflow prevention device should be fitted to fluid category 4 standards Scottish Water Byelaws (2014)</p> <p>CATEGORY: 3</p> <p>Lag pipework to reduce any possible thermal gain or loss. HSG 274 Part 2: Para 2.36 & 2.37</p>
How is the water heated?	Gas			
Is supply pipe fitted with check valve?	Yes			
Materials / Manufacturer	Copper / Worcester			
Is the heater working and in regular use?	Yes			
Temperatures	Cold supply	Hot outlet	Gauge

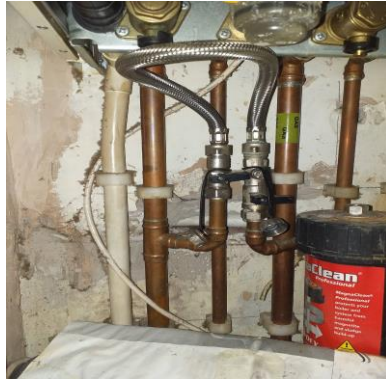
Filling loop connected at boiler

- All hot and cold water pipework should be insulated to reduce thermal loss or gain.
- The filling loop for the combination should only be connected when required to top up the central heating system.
