LEGIONELLA RISK ASSESSMENT

DOMESTIC WATER SYSTEMS

CUSTOMER: ROSEHILL HOUSING ASSOCIATION

SITE: 5 NEWMILNS STREET

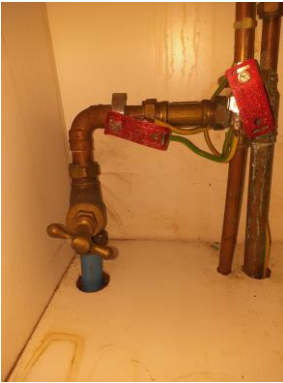
Incoming Main

<i>Location</i>	Kitchen	<i>Recommendations / Comments</i>
System ID No.	1	<p style="text-align: center;">CATEGORY: 3</p> <p style="text-align: center;">Lag pipework to reduce any possible thermal gain or loss.</p> <p style="text-align: center;">HSG 274 Part 2: Para 2.36 & 2.37</p>
Type	Town Mains	
Supply company	Scottish Water	
Labelled	No	
Insulation	No	
Material	MDPE	
Drain / injection point	No	
Temperature	10.3°C	
Isolation valve	Yes	
Accessibility	Good	
Additional comments	-	
Level of Risk	LOW

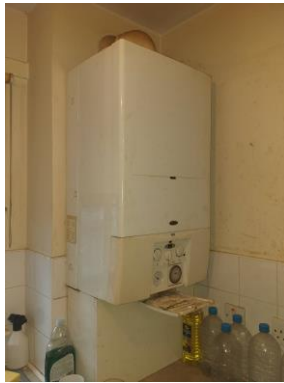
Combination Boiler

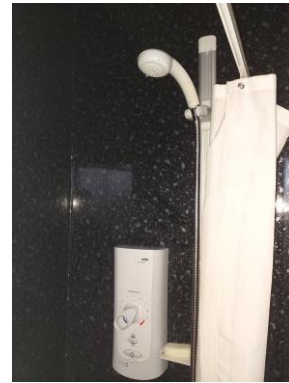
Electric Shower

Location		Kitchen	Bathroom	Toilet	Recommendations
System ID No(s)		1 and 2	1 and 2	1 and 2	<p>CATEGORY: 2</p> <p>Clean + disinfect showerheads and hoses quarterly HSG 274 Part 2: Table 2.1</p> <p>Remove dead leg pipework. HSG 274 Part 2: Para 2.77</p>
Dead Ends		Yes	None Visible	None Visible	
Spray Potential		Low	High	Low	
Cold temp after 2 min (°C)		10.4	10.6	10.4	
Hot temp after 1 min (°C)		54.8	55.5	54.1	
No of TMV's in location		-	-	-	
TMV	Cold In (°C)	-	-	-	
	Hot In (°C)	-	-	-	
	Mixed Out (°C)	-	-	-	
Frequency of Use		Daily	Daily	Daily	
Additional Comments		Dead leg under sink on hot water pipework.	-	-	
Outlets in Location		Sink, Washing machine.	WC Cistern, Electric shower, Wash hand basin.	WC Cistern, Wash hand basin.	
Additional Localised Risk		MEDIUM	MEDIUM	LOW

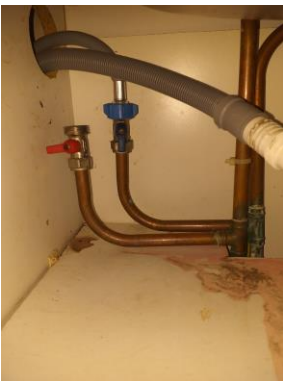
Dead leg in Kitchen

- Showerheads and hoses should be cleaned, descaled and disinfected quarterly.
- Insulation should be fitted to all hot and cold water pipework to reduce thermal loss or gain.
- The dead leg under the kitchen sink should be removed back to the nearest branch point.
