LEGIONELLA RISK ASSESSMENT

DOMESTIC WATER SYSTEMS

SITE: 10 GLENLORA DRIVE

SURVEY DATE: 4 NOVEMBER 2020

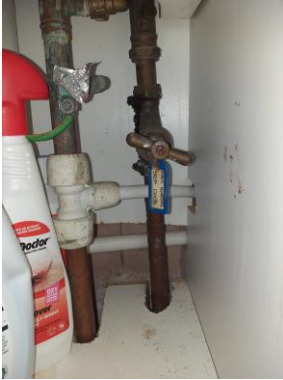
Incoming Main

<i>Location</i>	Kitchen	<i>Recommendations / Comments</i>
System ID No.	1	<p style="text-align: center;">CATEGORY: 3</p> <p style="text-align: center;">Lag pipework to reduce any possible thermal gain or loss.</p> <p style="text-align: center;">HSG 274 Part 2: Para 2.36 & 2.37</p>
Type	Town Mains	
Supply company	Scottish Water	
Labelled	Yes	
Insulation	No	
Material	Copper	
Drain / injection point	No	
Temperature	10.3°C	
Isolation valve	Yes	
Accessibility	Good	
Additional comments	-	
Level of Risk	LOW

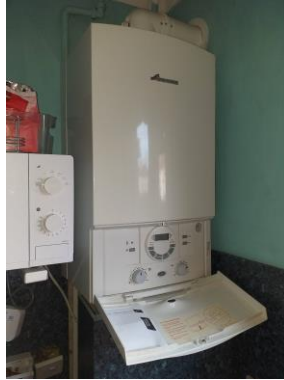
Combination Boiler

Location	Kitchen			Recommendations
System ID No.	2			<p>CATEGORY: 3</p> <p>Lag pipework to reduce any possible thermal gain or loss.</p> <p>HSG 274 Part 2: Para 2.36 & 2.37</p>
How is the water heated?	Gas			
Is supply pipe fitted with check valve?	Yes			
Materials / Manufacturer	Copper / Worcester			
Is the heater working and in regular use?	Yes			
Temperatures	Cold supply	Hot outlet	Gauge	
	11°C	61°C	-	
Dead ends on Pipework	No			
Non WRC Materials	No			
Is the pipework insulated?	No			
Is there an expansion vessel fitted?	Yes			
Is the quick fill loop still connected?	No			
Condition / Comments	-			
Level of Risk	LOW

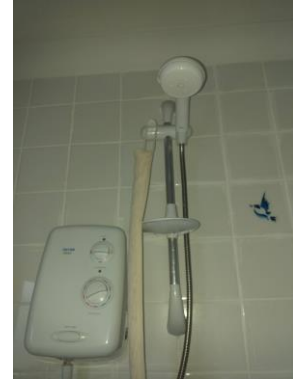
Electric Shower

Location		Kitchen	Bathroom	Recommendations
System ID No(s)		1 and 2	1 and 2	<p>CATEGORY: 2</p> <p>Clean + disinfect showerheads and hoses quarterly.</p> <p>HSG 274 Part 2: Table 2.1</p>
Dead Ends		None Visible	None Visible	
Spray Potential		Low	High	
Cold temp after 2 min (°C)		10.3	10.8	
Hot temp after 1 min (°C)		59.9	59.9	
No of TMV's in location		-	-	
TMV	Cold In (°C)			
	Hot In (°C)			
	Mixed Out (°C)			
Frequency of Use		Daily	Daily	
Additional Comments			-	
Outlets in Location		Sink, Washing machine.	WC Cistern, Bath, Wash Hand Basin, Electric shower.	
Additional Localised Risk		LOW	MEDIUM
