LEGIONELLA RISK ASSESSMENT

DOMESTIC WATER SYSTEMS

CUSTOMER: ROSEHILL HOUSING ASSOCIATION

SITE: 16 GLENTYAN PLACE

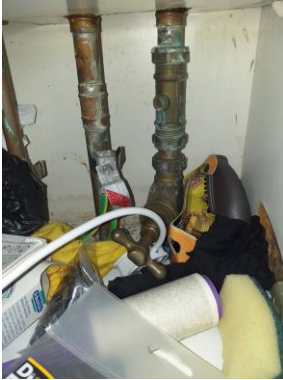
Incoming Main

<i>Location</i>	Under Kitchen Sink	<i>Recommendations / Comments</i>
System ID No.	1	<p style="text-align: center;">CATEGORY: 3</p> <p>Lag pipework to reduce any possible thermal gain or loss. HSG 274 Part 2: Para 2.36 & 2.37</p>
Type	Town Mains	
Supply company	Scottish Water	
Labelled	No	
Insulation	No	
Material	Copper	
Drain / injection point	No	
Temperature	10.8°C	
Isolation valve	Yes	
Accessibility	Good	
Additional comments	-	
Level of Risk	LOW

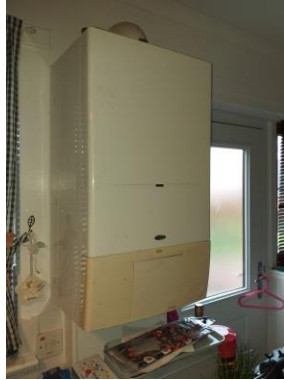
Combination Boiler

<i>Location</i>	Kitchen			<i>Recommendations</i>
<i>System ID No.</i>	2			<p>CATEGORY: 3</p> <p>Lag pipework to reduce any possible thermal gain or loss.</p> <p>HSG 274 Part 2: Para 2.36 & 2.37</p>
<i>How is the water heated?</i>	Gas			
<i>Is supply pipe fitted with check valve?</i>	No			
<i>Materials / Manufacturer</i>	Copper / Vokera			
<i>Is the heater working and in regular use?</i>	Yes			
<i>Temperatures</i>	Cold supply	Hot outlet	Gauge	
	10.9°C	58.5°C	59°C	
<i>Dead ends on Pipework</i>	No			
<i>Non WRC Materials</i>	No			
<i>Is the pipework insulated?</i>	No			
<i>Is there an expansion vessel fitted?</i>	Yes			
<i>Is the quick fill loop still connected?</i>	No			
<i>Condition / Comments</i>	-			
<i>Level of Risk</i>	LOW
