# LEGIONELLA RISK ASSESSMENT

## DOMESTIC WATER SYSTEMS

**CUSTOMER:** ROSEHILL HOUSING ASSOCIATION

**SITE:** 19 JOHNSBURN DRIVE

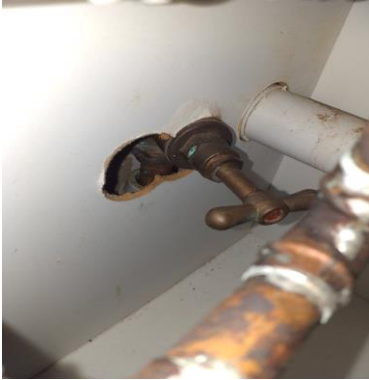
Mains Isolation Valve

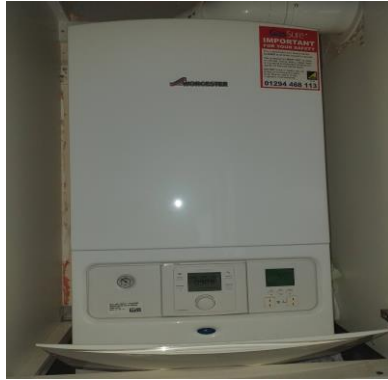
Combination Boiler

<i>Location</i>	Kitchen			<i>Recommendations</i>
<i>System ID No.</i>	2			<p align="center"><b>CATEGORY: 2</b></p> <p>Lag pipework to reduce any possible thermal gain or loss. <b>HSG 274 Part 2: Para 2.36 &amp; 2.37</b></p>
<i>How is the water heated?</i>	Gas			
<i>Is supply pipe fitted with check valve?</i>	Yes			
<i>Materials / Manufacturer</i>	Copper / Worcester			
<i>Is the heater working and in regular use?</i>	Yes / No			
<i>Temperatures</i>	Cold supply	Hot outlet	Gauge	
	11.6°C	57.8°C	58.0°C	
<i>Dead ends on Pipework</i>	No			
<i>Non WRC Materials</i>	No			
<i>Is the pipework insulated?</i>	No			
<i>Is there an expansion vessel fitted?</i>	Yes			
<i>Is the quick fill loop still connected?</i>	No			
<i>Condition / Comments</i>	-			
<i>Level of Risk</i>	<b>LOW</b>

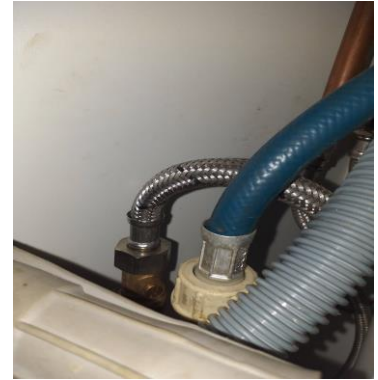
WRAS approved)

Representation of Flexible Hoses (hoses appear to be

Location		Kitchen	Bathroom	Recommendations
System ID No(s)		1 and 2	1 and 2	<p><b>CATEGORY: 2</b></p> <p>Clean + disinfect showerheads and hoses quarterly.</p> <p><b>HSG 274 Part 2: Table 2.1</b></p>
Dead Ends		None Visible	None Visible	
Spray Potential		Low	High	
Cold temp after 2 min (°C)		11.5	11.7	
Hot temp after 1 min (°C)		55.8	54.1	
No of TMV's in location		-	-	
TMV	Cold In (°C)	-	-	
	Hot In (°C)	-	-	
	Mixed Out (°C)	-	-	
Frequency of Use		Daily	Daily	
Additional Comments		-	-	
Outlets in Location		Sink, Washing machine	WC Cistern, Bath, Wash hand basin, Electric shower	
Additional Localised Risk		<b>LOW</b>	<b>MEDIUM</b>

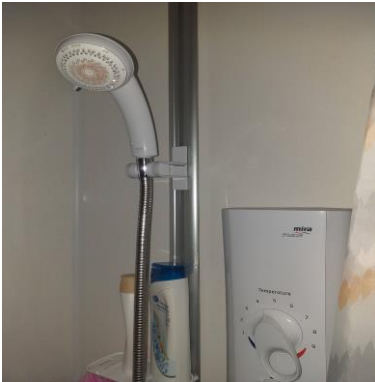
Electric Shower
