LEGIONELLA RISK ASSESSMENT

DOMESTIC WATER SYSTEMS

CUSTOMER: ROSEHILL HOUSING ASSOCIATION

SITE: 22 MAYBOLE STREET

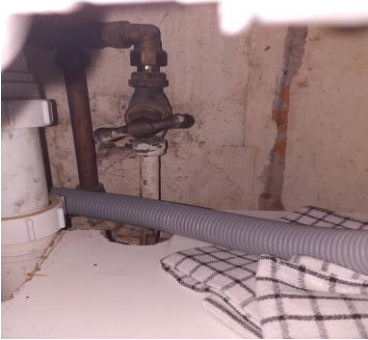
<i>Location</i>	Under Kitchen Sink	<i>Recommendations / Comments</i>
System ID No.	1	<p style="text-align: center;">CATEGORY: 3</p> <p>Lag pipework to reduce any possible thermal gain or loss. HSG 274 Part 2: Para 2.36 & 2.37</p>
Type	Town Mains	
Supply company	Scottish Water	
Labelled	No	
Insulation	No	
Material	Copper	
Drain / injection point	No	
Temperature	10.°C	
Isolation valve	Yes	
Accessibility	Good	
Additional comments	-	
Level of Risk	LOW

Incoming Main

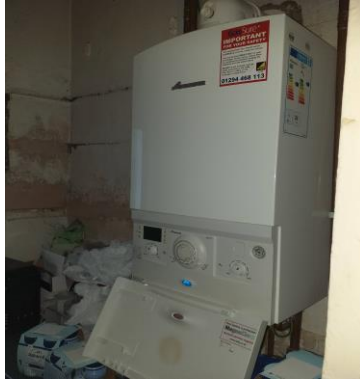
Location	Kitchen			Recommendations
System ID No.	2			<p>CATEGORY: 3</p> <p>Lag pipework to reduce any possible thermal gain or loss. HSG 274 Part 2: Para 2.36 & 2.37</p>
How is the water heated?	Gas			
Is supply pipe fitted with check valve?	Yes			
Materials / Manufacturer	Copper / Worcester			
Is the heater working and in regular use?	Yes			
Temperatures	Cold supply	Hot outlet	Gauge	
	11.5°C	56.1°C	57.8°C	
Dead ends on Pipework	No			
Non WRC Materials	No			
Is the pipework insulated?	No			
Is there an expansion vessel fitted?	Yes			
Is the quick fill loop still connected?	No			
Condition / Comments	-			
Level of Risk	LOW

Combination Boiler

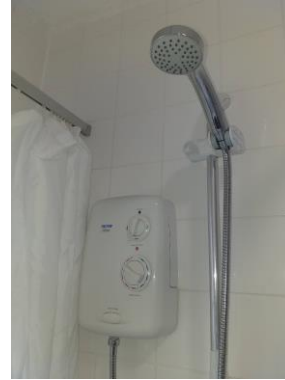
Location		Kitchen	Bathroom	Recommendations
System ID No(s)		1 and 2	1 and 2	<p>CATEGORY: 2</p> <p>Clean + disinfect showerheads and hoses quarterly.</p> <p>HSG 274 Part 2: Table 2.1</p>
Dead Ends		None Visible	None Visible	
Spray Potential		Low	High	
Cold temp after 2 min (°C)		11.6	11.8	
Hot temp after 1 min (°C)		52.7	51.4	
No of TMV's in location		-	-	
TMV	Cold In (°C)	-	-	
	Hot In (°C)	-	-	
	Mixed Out (°C)	-	-	
Frequency of Use		Daily	Daily	
Additional Comments		-	-	
Outlets in Location		Sink, Washing machine	Wash hand basin, WC Cistern, Electric shower	
Additional Localised Risk		LOW	MEDIUM

Electric Shower

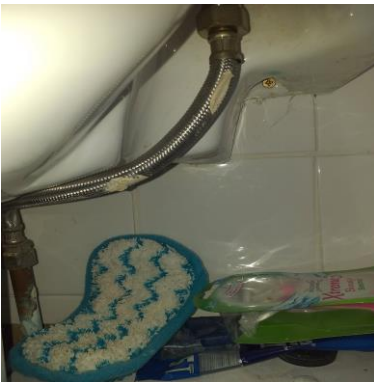
Representation of
Flexible Hoses

- Showerheads and hoses should be cleaned, descaled and disinfected quarterly.
- It was observed that flexible hoses are fitted, these should be replaced with seamless copper or ensure hoses are of WRAS approved verity.
- Insulation should be fitted to all hot and cold water pipework to reduce thermal loss or gain.
