LEGIONELLA RISK ASSESSMENT

DOMESTIC WATER SYSTEMS

CUSTOMER: ROSEHILL HOUSING ASSOCIATION

SITE: 27 MAYBOLE STREET

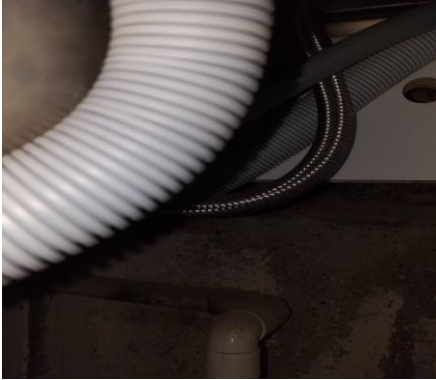
Flexible Hoses

- Showerheads and hoses should be cleaned, descaled and disinfected quarterly.
- It was observed that flexible hoses have been fitted. Ensure that flexible hoses are WRAS approved or replace with seamless copper.
- Remove quick fill link between mains supply and closed central heating systems.

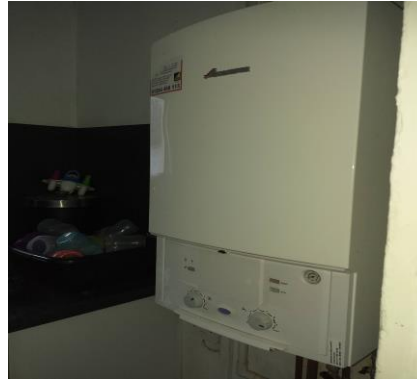
Combination Boiler

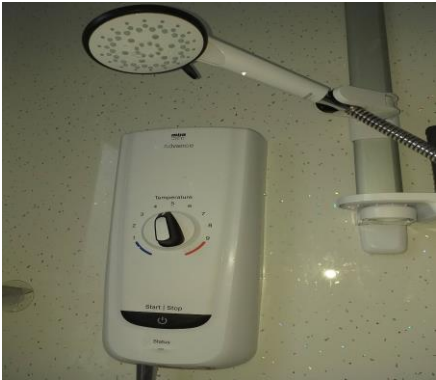
Electric Shower

Location		Kitchen	Bathroom	Recommendations
System ID No(s)		1 and 2	1 and 2	<p>CATEGORY: 2</p> <p>Clean + disinfect showerheads and hoses quarterly. HSG 274 Part 2: Table 2.1</p>
Dead Ends		None Visible	None Visible	
Spray Potential		Low	High	
Cold temp after 2 min (°C)		10.4	11.0	
Hot temp after 1 min (°C)		52.7	51.8	
No of TMV's in location		-	-	
TMV	Cold In (°C)			
	Hot In (°C)			
	Mixed Out (°C)			
Frequency of Use		Daily	Daily	
Additional Comments		-	-	
Outlets in Location		Sink, Washing machine.	Wash hand basin, WC Cistern, Electric Shower.	
Additional Localised Risk		LOW	MEDIUM

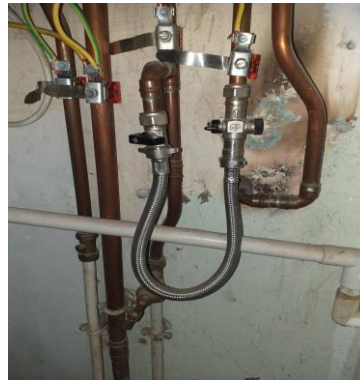
Filling Loop
Connected at Boiler

Location	Kitchen			Recommendations
System ID No.	2			<p>CATEGORY: 2</p> <p>Remove quick fill link between mains supply and closed central heating systems. If systems contain anti-freeze or corrosion inhibitor such as Glycol a backflow prevention device should be fitted to fluid category 4 standards Scottish Water Byelaws (2014)</p> <p>CATEGORY: 3</p> <p>Lag pipework to reduce any possible thermal gain or loss. HSG 274 Part 2: Para 2.36 & 2.37</p>
How is the water heated?	Gas			
Is supply pipe fitted with check valve?	Yes			
Materials / Manufacturer	Copper / Worcester			
Is the heater working and in regular use?	Yes			
Temperatures	Cold supply	Hot outlet	Gauge	
	11°C	53.9°C	-	
Dead ends on Pipework	No			
Non WRC Materials	No			
Is the pipework insulated?	No			
Is there an expansion vessel fitted?	Yes			
Is the quick fill loop still connected?	Yes			
Condition / Comments	-			
Level of Risk	MEDIUM
