LEGIONELLA RISK ASSESSMENT

DOMESTIC WATER SYSTEMS

CUSTOMER: ROSEHILL HOUSING ASSOCIATION

SITE: 29 PRIESTHILL ROAD - FLAT 1/1

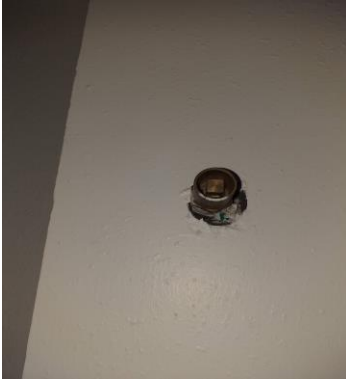
<i>Location</i>	External stairwell	<i>Recommendations / Comments</i>
System ID No.	1	
Type	Town Mains	
Supply company	Scottish Water	
Labelled	No	
Insulation	Unknown	
Material	Unknown	
Drain / injection point	Unknown	
Temperature	10.6°C at kitchen sink.	
Isolation valve	Yes	
Accessibility	Access to isolation valve only	
Additional comments	-	
Level of Risk	LOW

Mains Isolation Valve

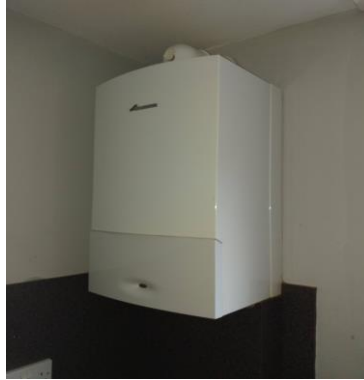
Location	Kitchen			Recommendations
System ID No.	2			<p>CATEGORY: 3</p> <p>Lag pipework to reduce any possible thermal gain or loss. HSG 274 Part 2: Para 2.36 & 2.37</p>
How is the water heated?	Gas			
Is supply pipe fitted with check valve?	Yes			
Materials / Manufacturer	Copper / Worcester			
Is the heater working and in regular use?	Flat is currently unoccupied			
Temperatures	Cold supply	Hot outlet	Gauge	
	10.4°C	10.6°C	-	
Dead ends on Pipework	No			
Non WRC Materials	No			
Is the pipework insulated?	No			
Is there an expansion vessel fitted?	Yes			
Is the quick fill loop still connected?	No			
Condition / Comments	-			
Level of Risk	MEDIUM

Combination Boiler
