# LEGIONELLA RISK ASSESSMENT

## DOMESTIC WATER SYSTEMS

**CUSTOMER:** ROSEHILL HOUSING ASSOCIATION

**SITE:** 39 LUNDERSTON DRIVE

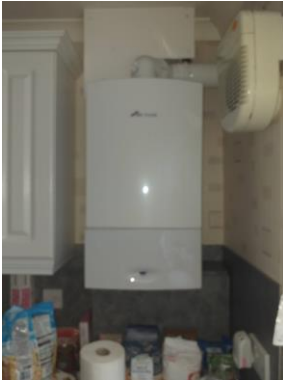
Combination Boiler

Location	Kitchen			Recommendations
System ID No.	2			<p><b>CATEGORY: 3</b></p> <p>Lag pipework to reduce any possible thermal gain or loss.</p> <p><b>HSG 274 Part 2: Para 2.36 &amp; 2.37</b></p>
How is the water heated?	Gas			
Is supply pipe fitted with check valve?	Yes			
Materials / Manufacturer	Copper / Worcester			
Is the heater working and in regular use?	Yes			
Temperatures	Cold supply	Hot outlet	Gauge	
	11°C	61°C	-	
Dead ends on Pipework	No			
Non WRC Materials	No			
Is the pipework insulated?	No			
Is there an expansion vessel fitted?	Yes			
Is the quick fill loop still connected?	No			
Condition / Comments	-			
Level of Risk	<b>LOW</b>

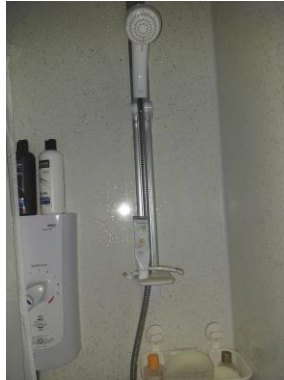
Electric Shower

Location		Kitchen	Bathroom	Recommendations
System ID No(s)		1 and 2	1 and 2	<p><b>CATEGORY: 2</b></p> <p>Clean + disinfect showerheads and hoses quarterly.</p> <p><b>HSG 274 Part 2: Table 2.1</b></p>
Dead Ends		None Visible	None Visible	
Spray Potential		Low	High	
Cold temp after 2 min (°C)		10.6	10.8	
Hot temp after 1 min (°C)		58.9	57.7	
No of TMV's in location		-	-	
TMV	Cold In (°C)	-	-	
	Hot In (°C)	-	-	
	Mixed Out (°C)	-	-	
Frequency of Use		Daily	Daily	
Additional Comments		-	-	
Outlets in Location		Sink, Washing machine.	Electric shower, WC Cistern, Wash hand basin.	
Additional Localised Risk		<b>LOW</b>	<b>MEDIUM</b>

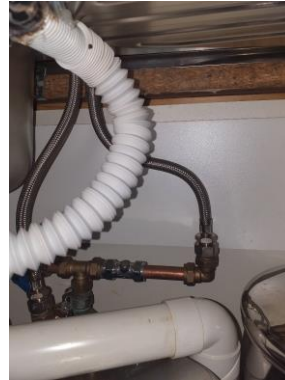
Representation of  
Flexible Hoses

- Showerheads and hoses should be cleaned, descaled and disinfected quarterly.
- It was observed that flexible hoses are fitted. Ensure flexible hoses are WRAS approved or replace with seamless copper pipe.
- Insulation should be fitted to all hot and cold water pipework to reduce thermal loss or gain.
