# LEGIONELLA RISK ASSESSMENT

## DOMESTIC WATER SYSTEMS

**CUSTOMER:** ROSEHILL HOUSING ASSOCIATION

**SITE:** 45 SEAMILL STREET

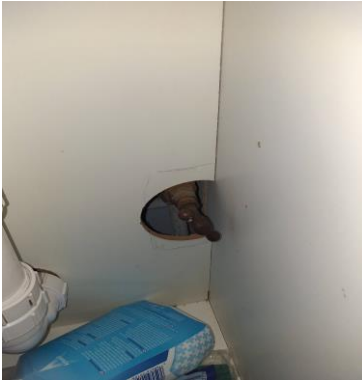
<i>Location</i>	Under Kitchen Sink	<i>Recommendations / Comments</i>
System ID No.	1	<p align="center"><b>CATEGORY: 3</b></p> <p>Lag pipework to reduce any possible thermal gain or loss.</p>
Type	Town Mains	
Supply company	Scottish Water	
Labelled	No	
Insulation	No	
Material	Unknown	
Drain / injection point	Unknown	
Temperature	11.4°C	
Isolation valve	Yes	
Accessibility	Satisfactory	
Additional comments	Access to isolation valve only.	
Level of Risk	<b>LOW</b>

Mains Isolation Valve

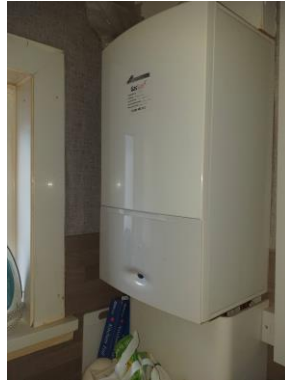
<i>Location</i>	Kitchen			<b><i>Recommendations</i></b>
<i>System ID No.</i>	2			<p align="center"><b>CATEGORY: 3</b></p> <p>Lag pipework to reduce any possible thermal gain or loss.</p> <p><b>HSG 274 Part 2: Para 2.36 &amp; 2.37</b></p>
<i>How is the water heated?</i>	Gas			
<i>Is supply pipe fitted with check valve?</i>	Yes			
<i>Materials / Manufacturer</i>	Copper			
<i>Is the heater working and in regular use?</i>	Yes			
<i>Temperatures</i>	Cold supply	Hot outlet	Gauge	
	11.6°C	58.9°C	54°C	
<i>Dead ends on Pipework</i>	No			
<i>Non WRC Materials</i>	No			
<i>Is the pipework insulated?</i>	No			
<i>Is there an expansion vessel fitted?</i>	Yes			
<i>Is the quick fill loop still connected?</i>	No			
<i>Condition / Comments</i>	-			
<i>Level of Risk</i>	<b>LOW</b>

Combination Boiler

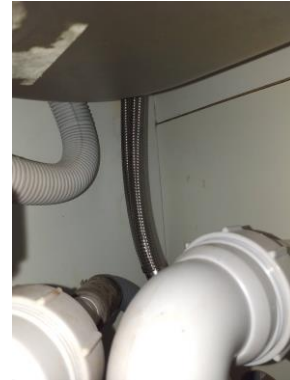
Representation of  
Flexible Hoses

- Showerheads and hoses should be cleaned, descaled and disinfected quarterly.
- It was observed that flexible hoses are fitted. Flexible hoses should be removed and replaced with seamless copper or WRAS approved hoses.
- Insulation should be fitted to all hot and cold water pipework to reduce thermal loss or gain.
