LEGIONELLA RISK ASSESSMENT

DOMESTIC WATER SYSTEMS

CUSTOMER: ROSEHILL HOUSING ASSOCIATION

SITE: 50 MAYBOLE STREET

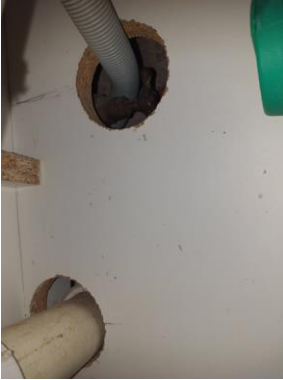
Mains Isolation Valve

<i>Location</i>	Under Kitchen Sink	<i>Recommendations / Comments</i>
System ID No.	1	<p style="text-align: center;">CATEGORY: 3</p> <p>Lag pipework to reduce any possible thermal gain or loss. HSG 274 Part 2: Para 2.36 & 2.37</p>
Type	Town Mains	
Supply company	Scottish Water	
Labelled	No	
Insulation	No	
Material	Limited access, unable to determine	
Drain / injection point	Limited access, unable to determine	
Temperature	9.7°C	
Isolation valve	Yes	
Accessibility	Access to isolation valve only	
Additional comments	-	
Level of Risk	LOW

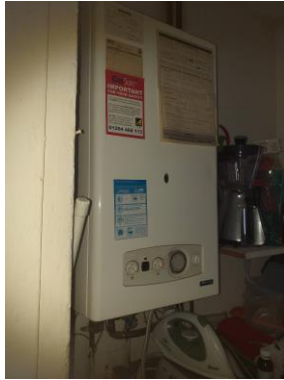
Combination Boiler

Location	Kitchen			Recommendations
System ID No.	2			<p>CATEGORY: 3</p> <p>Lag pipework to reduce any possible thermal gain or loss. HSG 274 Part 2: Para 2.36 & 2.37</p>
How is the water heated?	Gas			
Is supply pipe fitted with check valve?	Yes			
Materials / Manufacturer	Copper / Glow worm			
Is the heater working and in regular use?	Yes			
Temperatures	Cold supply	Hot outlet	Gauge	
	10.1°C	61.3°C	Not fitted	
Dead ends on Pipework	No			
Non WRC Materials	No			
Is the pipework insulated?	No			
Is there an expansion vessel fitted?	Yes			
Is the quick fill loop still connected?	No			
Condition / Comments	-			
Level of Risk	LOW

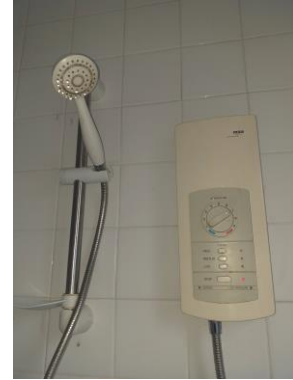
Electric Shower

Location		Kitchen	Bathroom	Recommendations
System ID No(s)		1 and 2	1 and 2	<p>CATEGORY: 2</p> <p>Clean + disinfect showerheads and hoses quarterly.</p> <p>HSG 274 Part 2: Table 2.1</p>
Dead Ends		None Visible	None Visible	
Spray Potential		Low	High	
Cold temp after 2 min (°C)		9.6	10.1	
Hot temp after 1 min (°C)		57.9	56.4	
No of TMV's in location		-	-	
TMV	Cold In (°C)			
	Hot In (°C)			
	Mixed Out (°C)			
Frequency of Use		Daily	Daily	
Additional Comments		-	-	
Outlets in Location		Sink, Washing machine	Electric shower, Bath, Wash hand basin, WC Cistern	
Additional Localised Risk		LOW	MEDIUM

- The showerhead and hose should be cleaned, descaled and disinfected quarterly.
- All hot and cold water pipes should be insulated to reduce thermal loss or gain.
