LEGIONELLA RISK ASSESSMENT

DOMESTIC WATER SYSTEMS

CUSTOMER: ROSEHILL HOUSING ASSOCIATION

SITE: 57 SEAMILL STREET

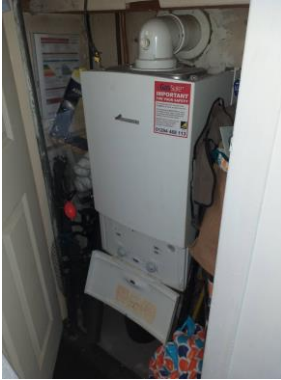
Combination Boiler

Location	Hall Cupboard			Recommendations
System ID No.	2			<p>CATEGORY: 3</p> <p>Lag pipework to reduce any possible thermal gain or loss.</p> <p>HSG 274 Part 2: Para 2.36 & 2.37</p>
How is the water heated?	Gas			
Is supply pipe fitted with check valve?	Yes			
Materials / Manufacturer	Copper / Worcester			
Is the heater working and in regular use?	Yes			
Temperatures	Cold supply	Hot outlet	Gauge	
	11.3°C	58.9°C	59°C	
Dead ends on Pipework	No			
Non WRC Materials	No			
Is the pipework insulated?	No			
Is there an expansion vessel fitted?	Yes			
Is the quick fill loop still connected?	No			
Condition / Comments	-			
Level of Risk	LOW

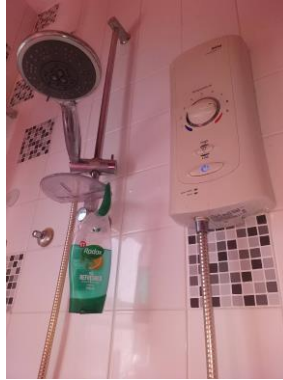
Electric Shower

Location		Kitchen	Bathroom	Recommendations
System ID No(s)		1 and 2	1 and 2	<p>CATEGORY: 2</p> <p>Clean + disinfect showerheads and hoses quarterly HSG 274 Part 2: Table 2.1</p> <p>Remove dead leg pipework. HSG 274 Part 2: Para 2.77</p>
Dead Ends		Yes	Yes	
Spray Potential		Low	High	
Cold temp after 2 min (°C)		11.0	11.4	
Hot temp after 1 min (°C)		56.8	57.1	
No of TMV's in location		-	-	
TMV	Cold In (°C)	-	-	
	Hot In (°C)	-	-	
	Mixed Out (°C)	-	-	
Frequency of Use		Daily	Daily	
Additional Comments		Dead leg beside washing machine on hot water pipework.	-	
Outlets in Location		Sink, Washing machine.	WC Cistern, Bath, Wash hand basin, Electric shower.	
Additional Localised Risk		MEDIUM	MEDIUM

- Showerheads and hoses should be cleaned, descaled and disinfected quarterly.
- It was observed that flexible hoses are fitted. Ensure flexible hoses are WRAS approved or replace with seamless copper.
- Insulation should be fitted to all hot and cold water pipework to reduce thermal loss or gain.
