# LEGIONELLA RISK ASSESSMENT

## DOMESTIC WATER SYSTEMS

**CUSTOMER:** ROSEHILL HOUSING ASSOCIATION

**SITE:** 59 SEAMILL STREET - GLASGOW

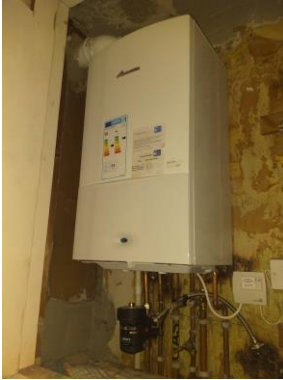
Combination Boiler

Location	Kitchen			Recommendations
System ID No.	2			Lag pipework to reduce any possible thermal gain or loss. <b>HSG 274 Part 2: Para 2.36 &amp; 2.37</b>
How is the water heated?	Gas			
Is supply pipe fitted with check valve?	Yes			
Materials / Manufacturer	Copper/Worcester			
Is the heater working and in regular use?	Yes			
Temperatures	Cold supply	Hot outlet	Gauge	
	11°C	11°C	72°C	
Dead ends on Pipework	No			
Non WRC Materials	No			
Is the pipework insulated?	No			
Is there an expansion vessel fitted?	Yes			
Is the quick fill loop still connected?	No			
Condition / Comments	-			
Level of Risk	<b>LOW</b>

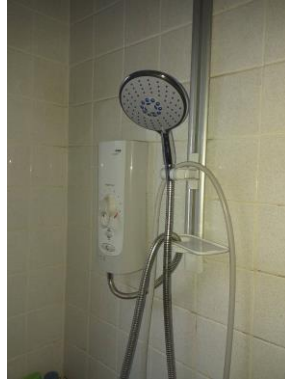
Electric Shower

Location		Kitchen	Bathroom	Recommendations
System ID No(s)		1 and 2	1 and 2	<p><b>CATEGORY: 2</b></p> <p>Clean + disinfect showerheads and hoses quarterly  <b>HSG 274 Part 2: Table 2.1</b></p>
Dead Ends		None Visible	None Visible	
Spray Potential		Low	High	
Cold temp after 2 min (°C)		10.9	11.2	
Hot temp after 1 min (°C)		58.7	58.3	
No of TMV's in location		-	-	
TMV	Cold In (°C)	-	-	
	Hot In (°C)	-	-	
	Mixed Out (°C)	-	-	
Frequency of Use		Daily	Daily	
Additional Comments		-	-	
Outlets in Location		Kitchen sink, Washing machine	Bath Wash hand basin, WC, Electric shower	
Additional Localised Risk		<b>LOW</b>	<b>MEDIUM</b>

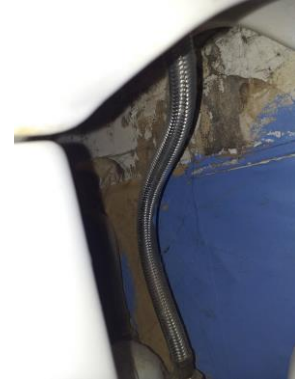
Representation of  
flexible hoses

- The showerhead and hose should be cleaned, descaled and disinfected quarterly
- The flexible hoses fitted at the WHB should be replaced with seamless copper or WRAS approved flexible hoses.
- Lag pipework to reduce any possible thermal gain or loss.
